Offcuts

Issue 37

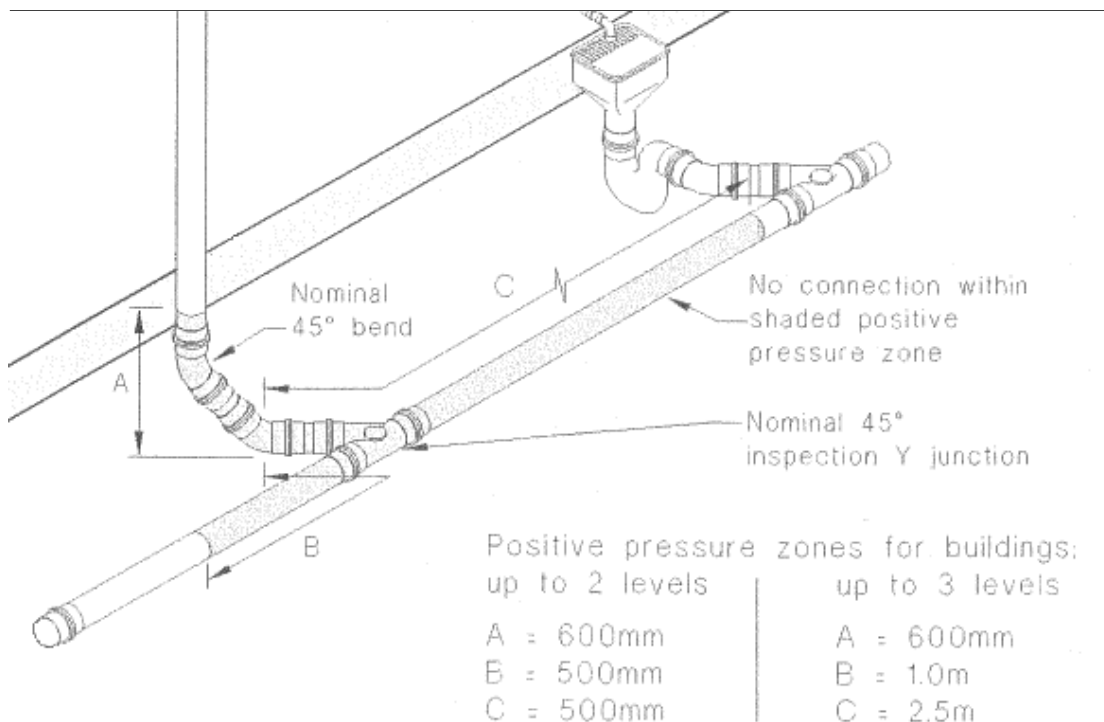
We have picked up on a number of recent soil stack installations where the bend at base of the stack has not been formed correctly. In these cases a large radius swept bend, or 2/ 45 degree bends are permitted. 100mm or even 80mm elbows are not acceptable.

Also remember that no connections to the stack or drain can be made within the 'positive pressure zone'
